Accelerated Sign Inventory and Management

July 21, 2015

- Research need
 - Introduction to sensing system
 - An enhanced sign inventory procedure
 - Case study on I-285
 - A prototype of GIS-based sign management system
 - Preliminary study of sign retroreflectivity condition assessment using mobile LiDAR
-

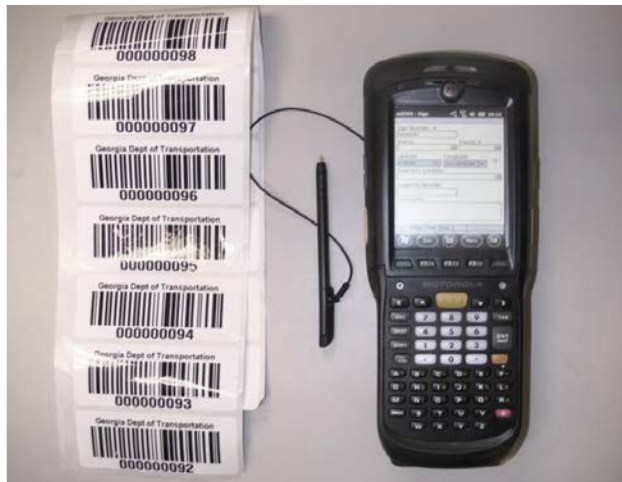
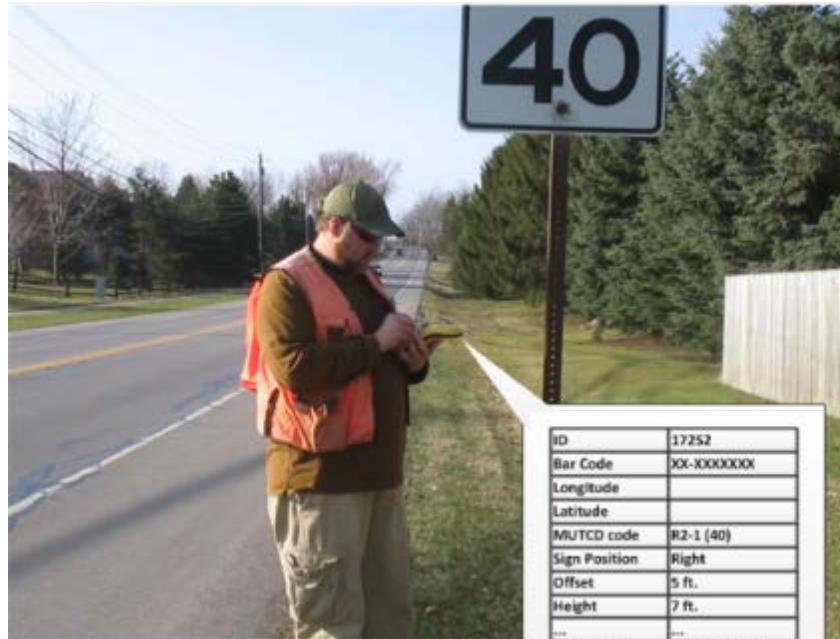
GDOT's Inventory on New Signs

- GPS-enabled PDA
- Barcode Scanner
- Digital camera

ID	17252
Bar Code	XXX-XXXXXXX
Longitude	
Latitude	
MUTCD code	R2-1 (40)
Sign Position	Right
Offset	5 ft.
Height	7 ft.
***	***
Image File	XXX-XXXXXXX.jpg

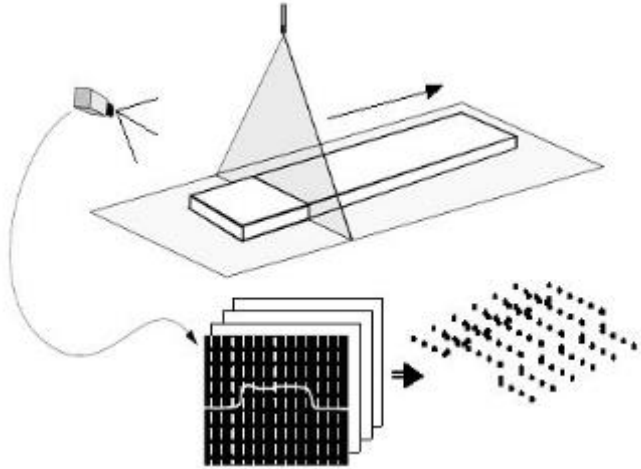
3D Line Laser Imaging

Transverse direction : 1 mm

Elevation: 0.5 mm

Data points collected per second
and width covered:

$2 \text{ (lasers)} * 2048$
 $\text{(points/profile/laser)} * 5600 \text{ HZ} =$
 $22,937,600 \text{ points}$

$2 \text{ (lasers)} * 2048$
 $\text{(points/profile/laser)} * 1 \text{ (mm)} =$
 4.096 m

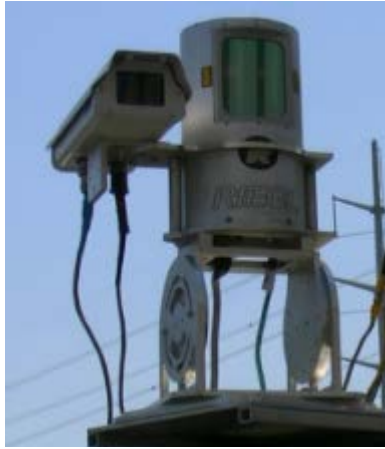
Mobile LiDAR and Digital Camera

High-resolution Light Detection And Ranging (LiDAR)

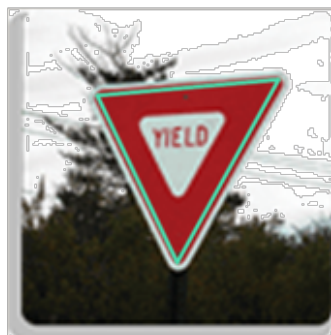
(a) Triangle

(b) Rectangle

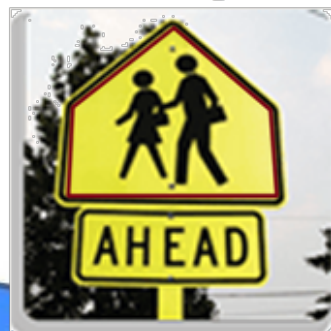
(c) Pentagon

(d) Octagon

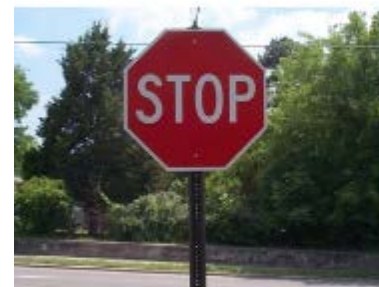
(c) validation column vector, generated by re-sampling (a) to the size of 50-elements

(e) reference stop sign column vector

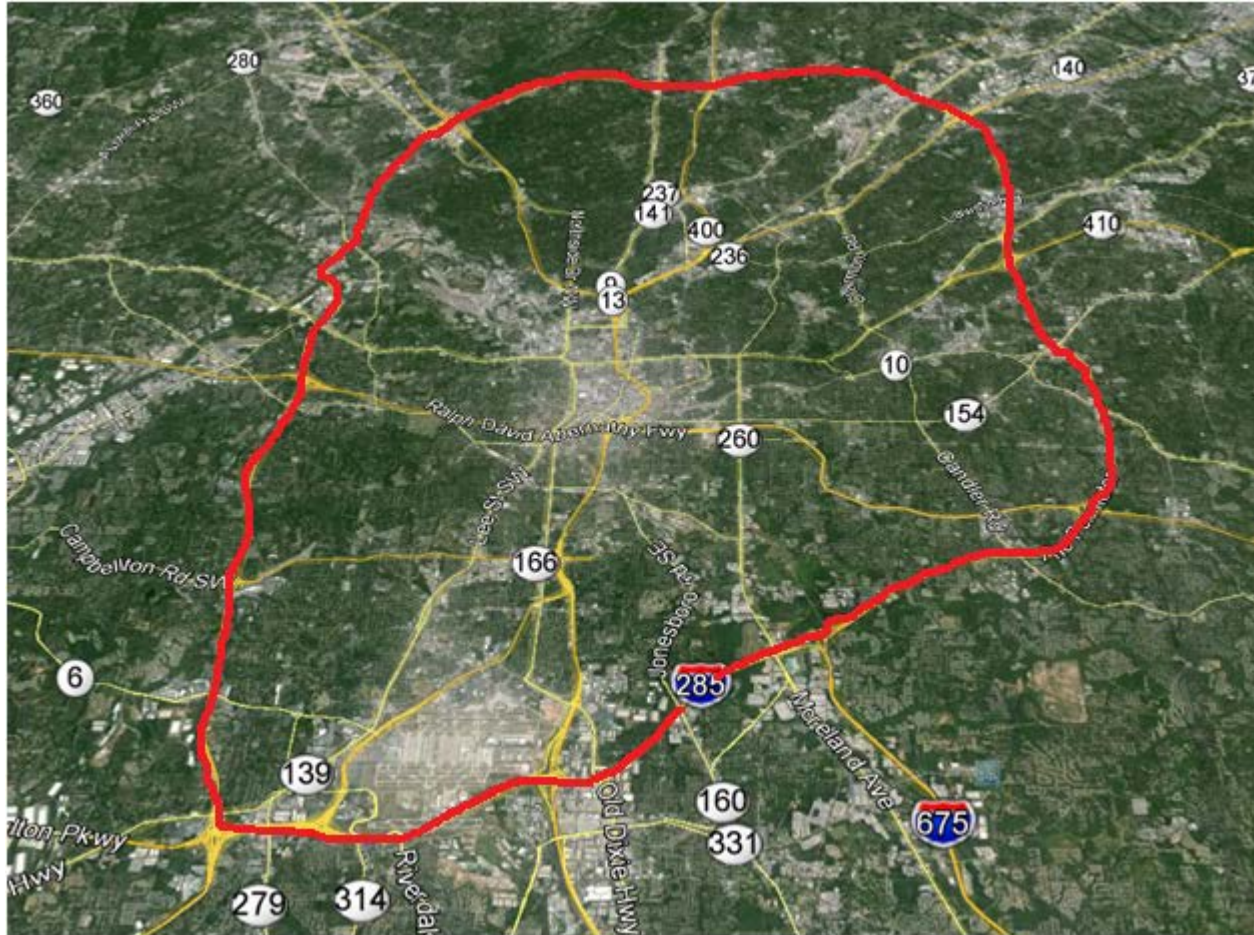
Large-scale Test on I-285

128 survey miles (two-way); more than 40,000 images captured

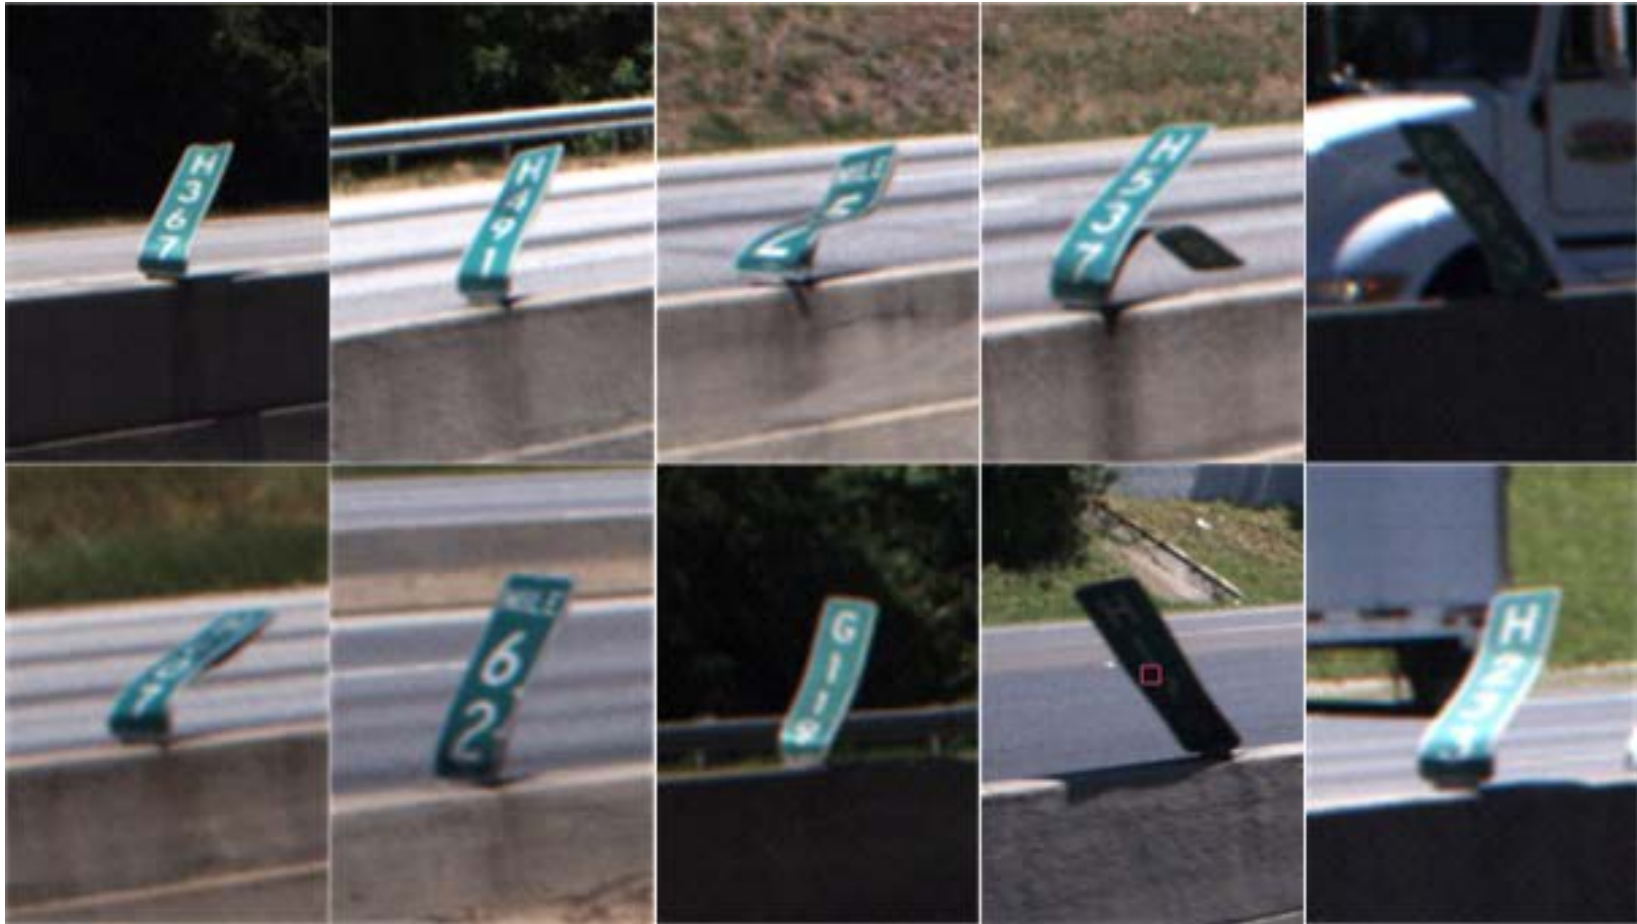
Example Damaged Signs (1) - *Truck Gust*

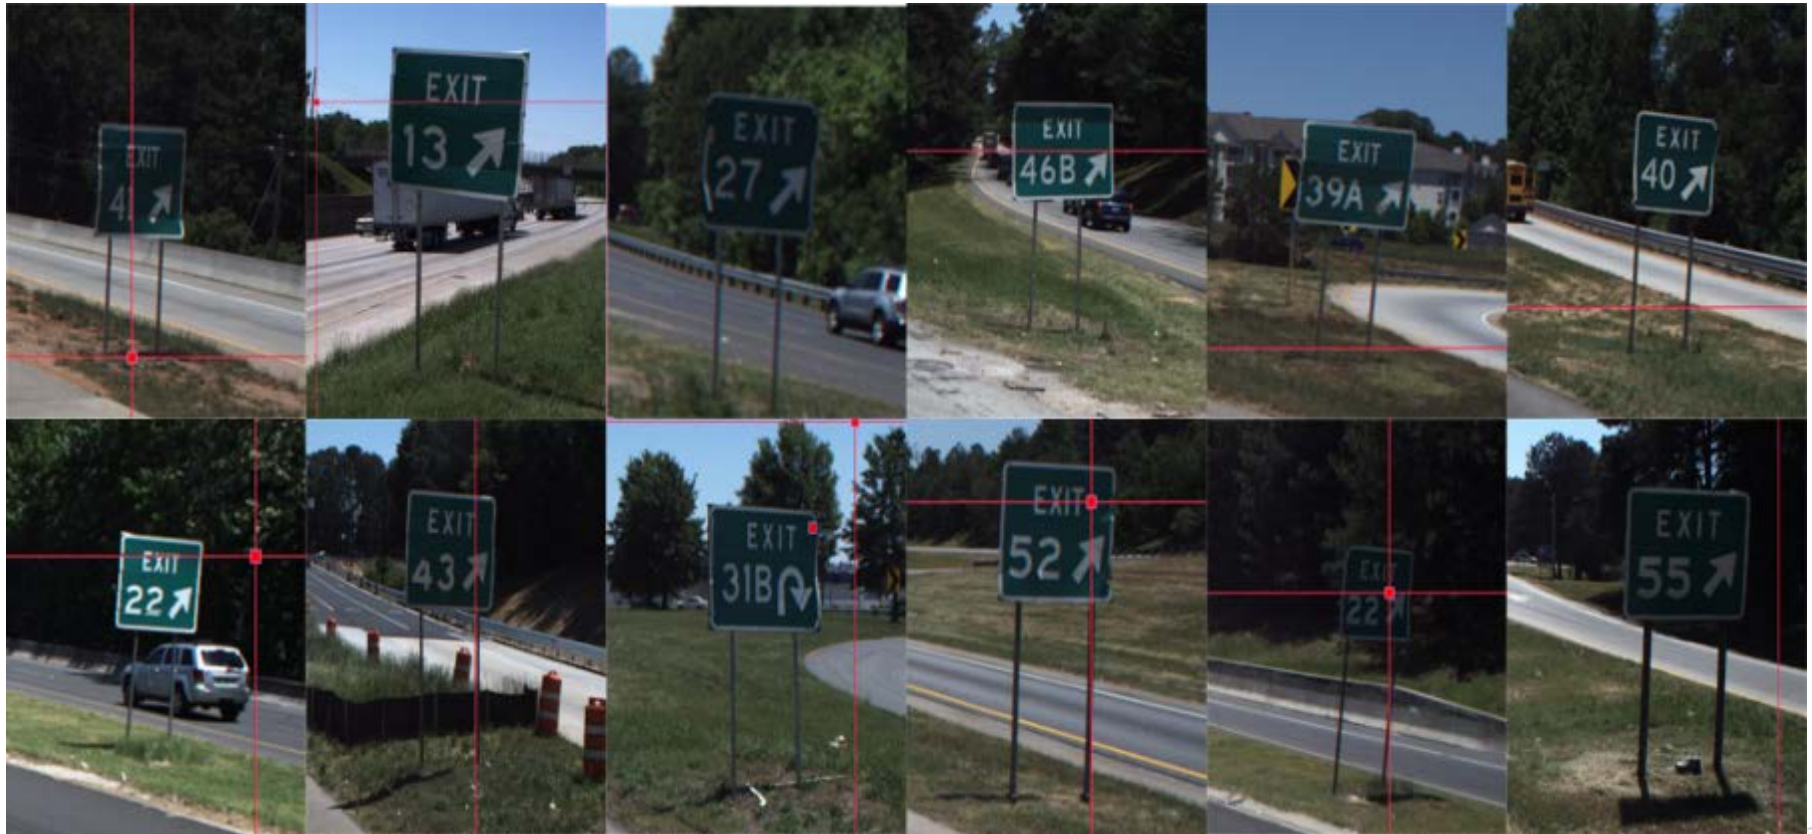
Example Damaged Signs (2) - Dual-Post

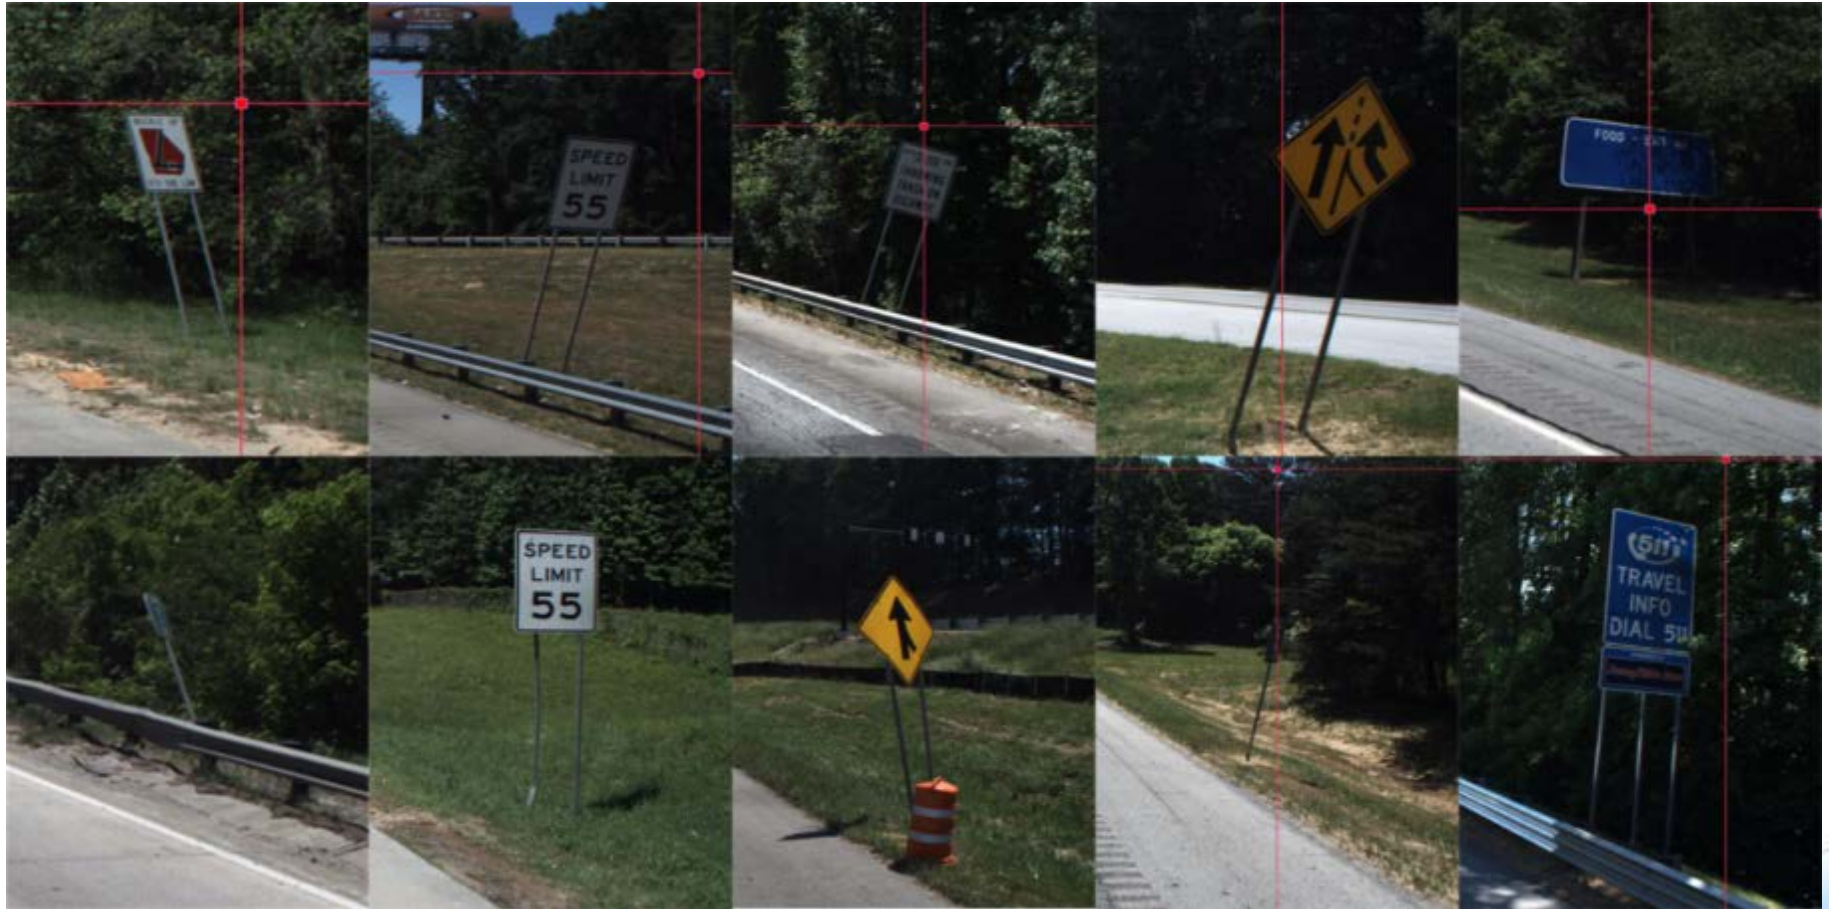
Example Damaged Signs (3) - *Post Failure*

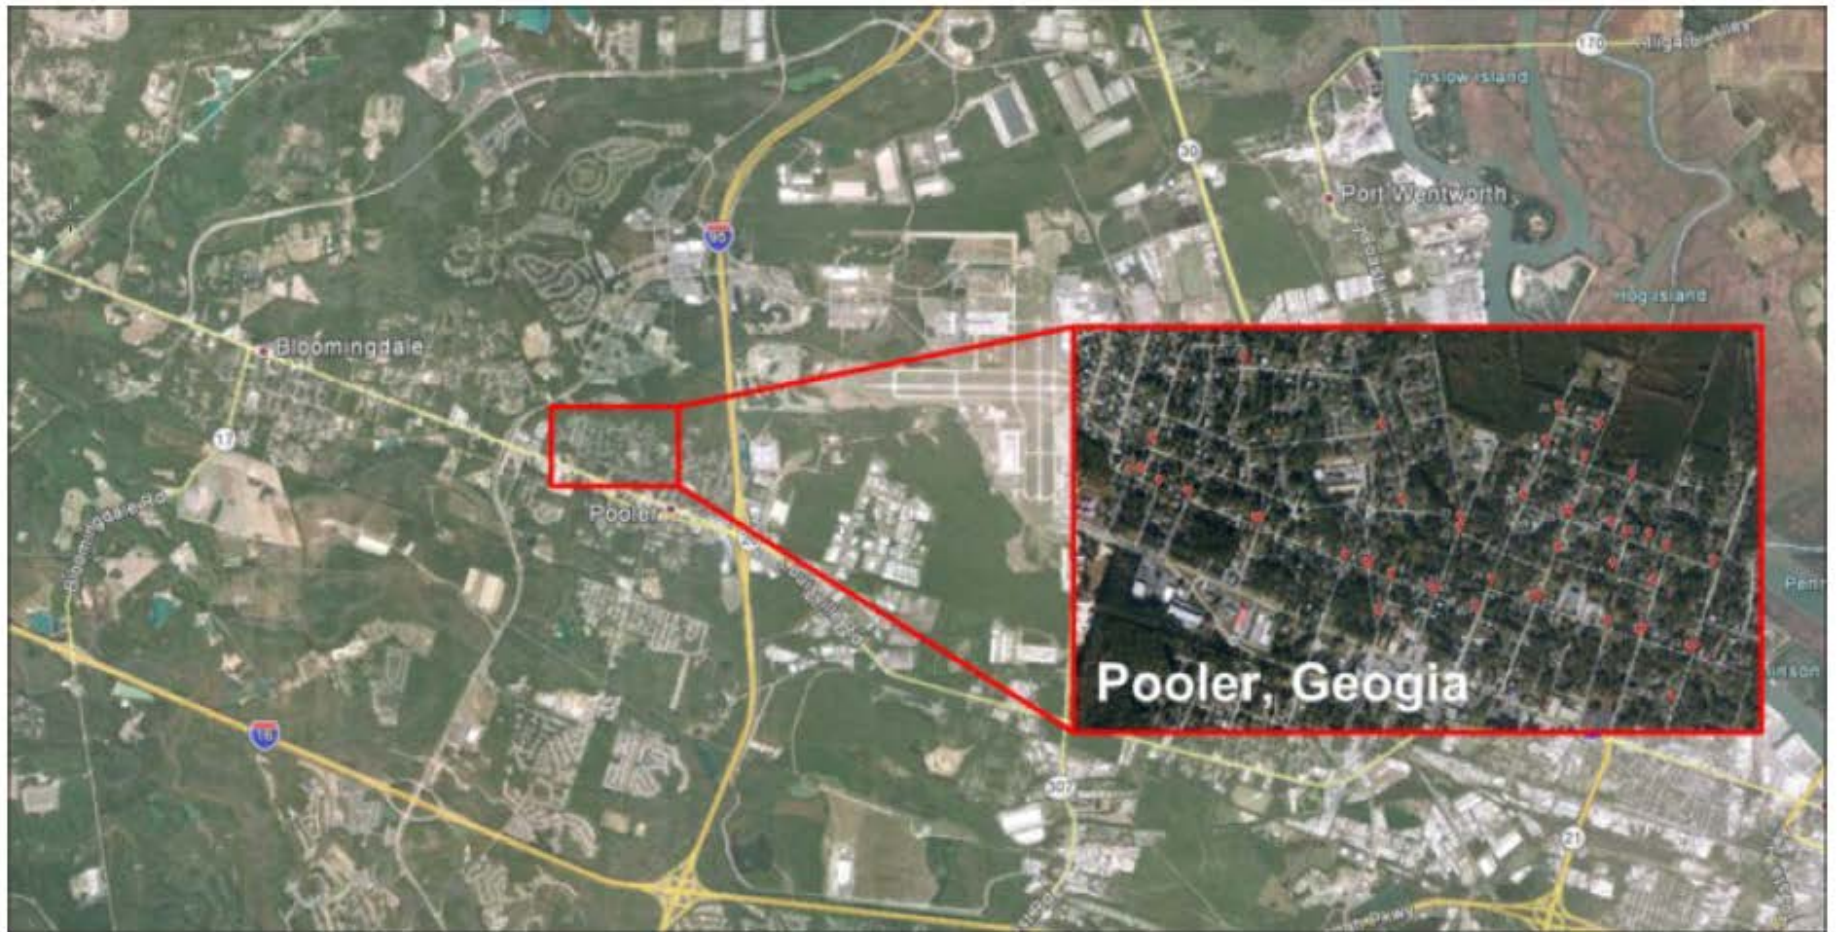
Thirty-five stop signs with engineer grade sheeting were collected in Pooler, Georgia

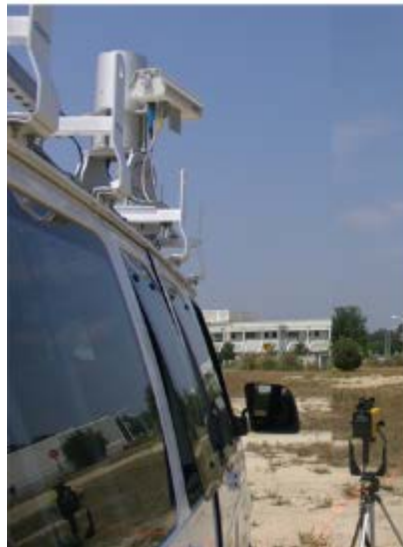
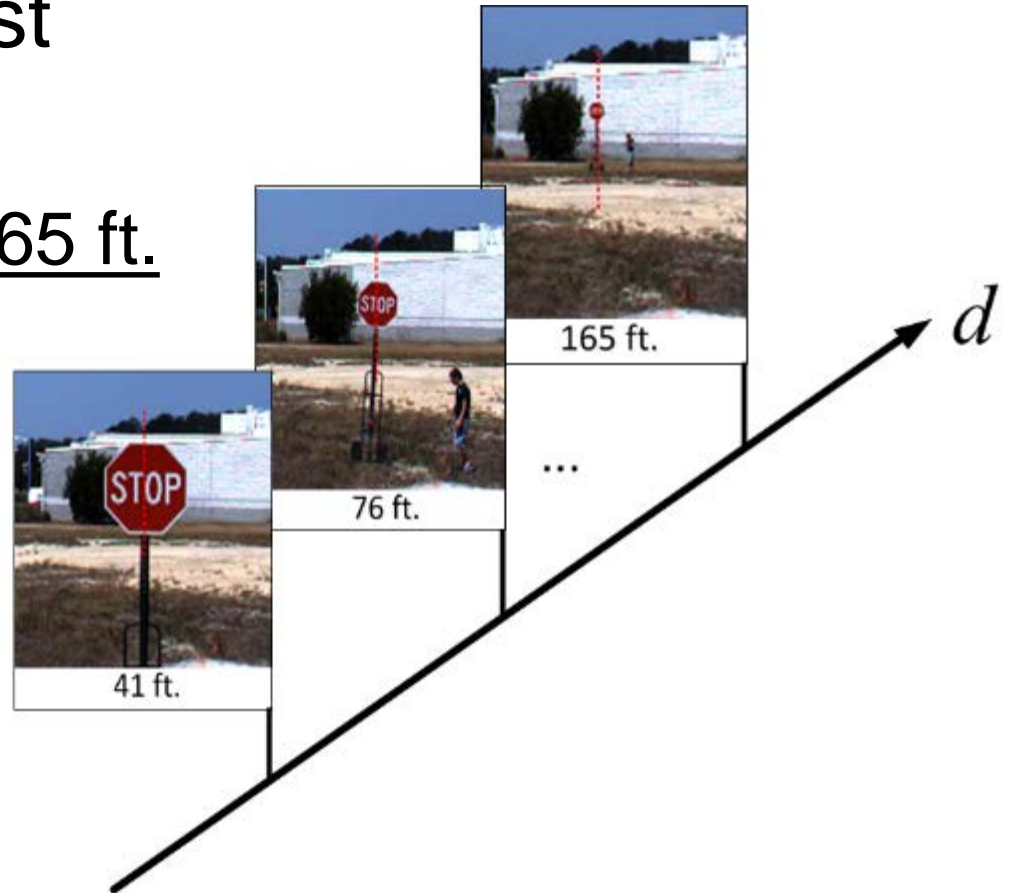
Retro-Intensity vs. Beam Distance

- Beam Distance Test
 - Angle $\alpha = 0^\circ$
 - Distance $d = 20 - 165$ ft.

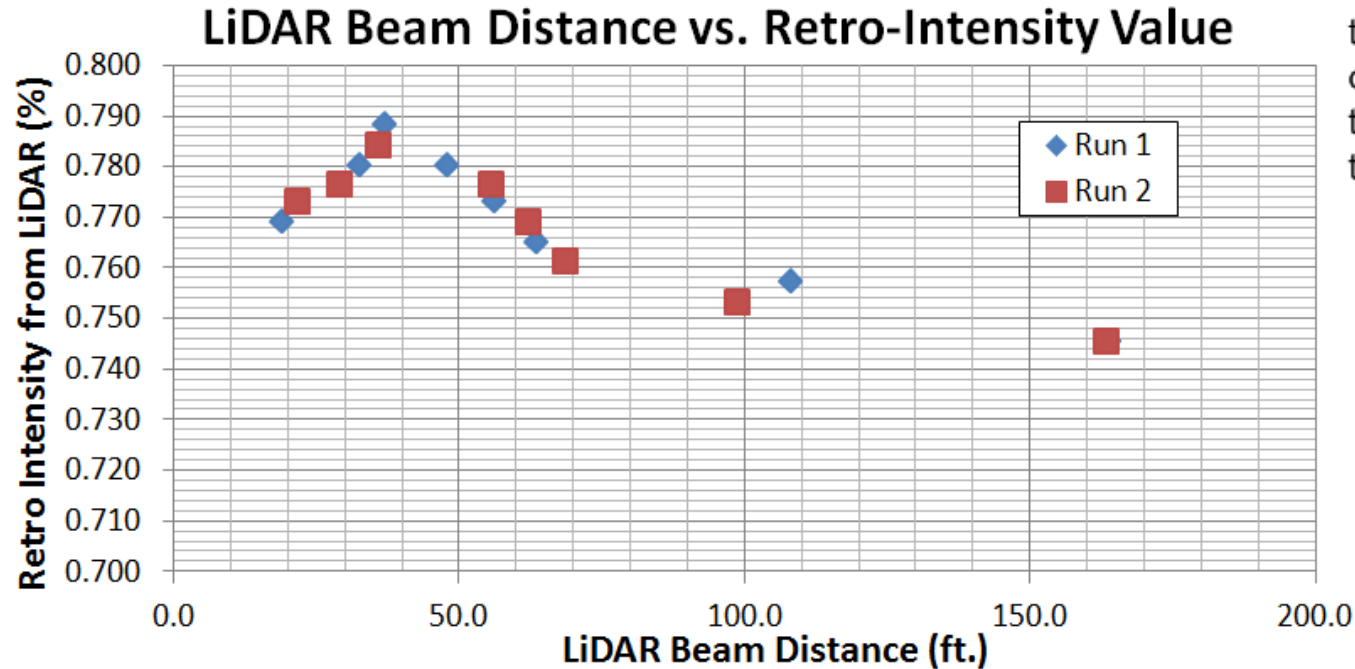
- Beam Distance Normalization

The retro-intensity value is normalized to the beam distance of 41 ft. by adding the value of $\Delta f(d)$ to the original value.

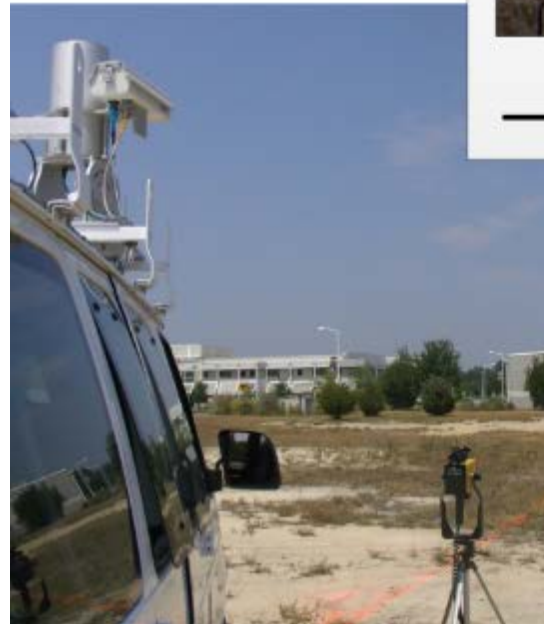
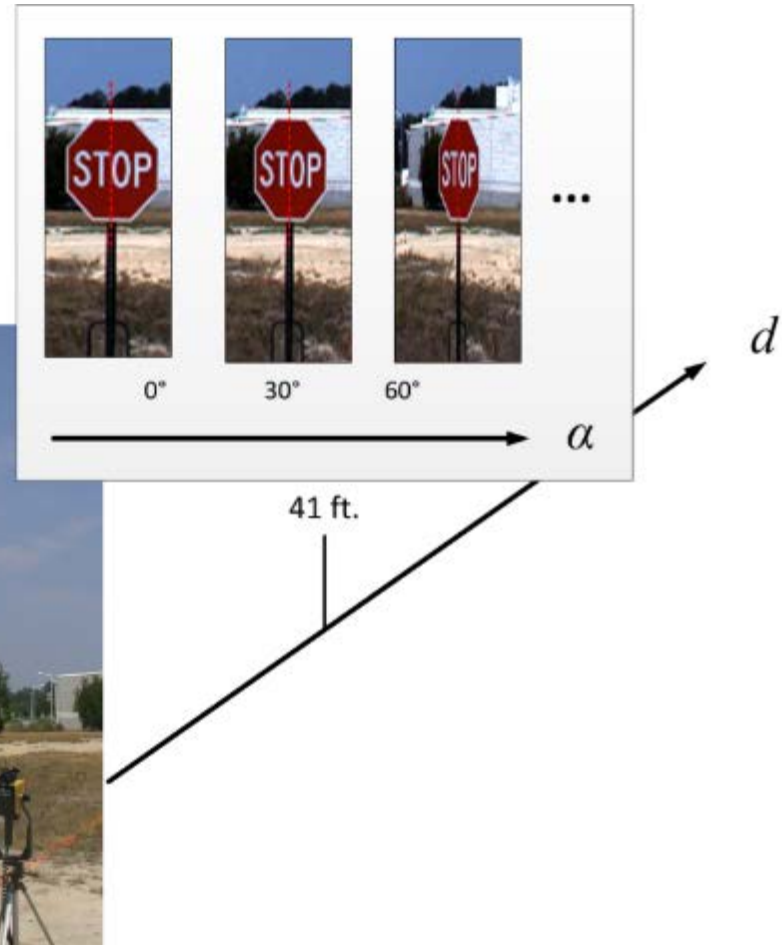
Retro-Intensity vs. Incidence Angle

- Incidence Angle Test
 - Angle $\alpha = 0 - 90^\circ$
 - Distance $d = 41$ ft.

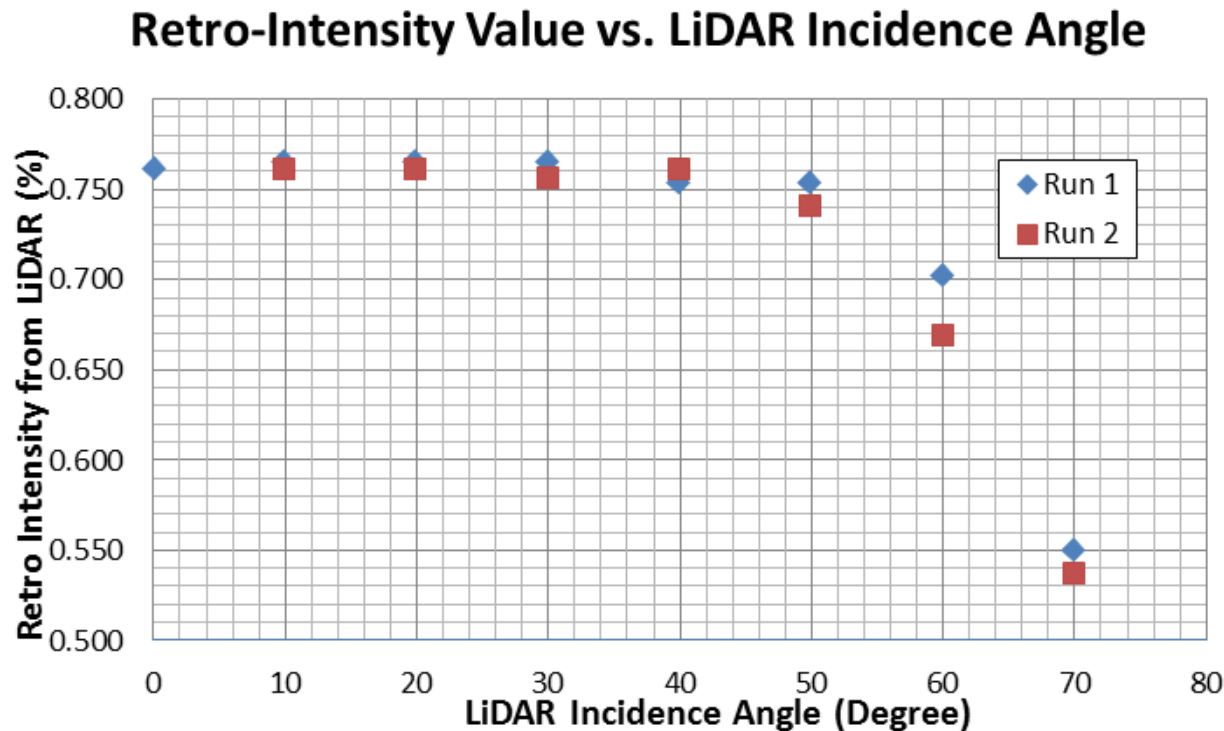
- Incidence Angle Normalization

The retro-intensity value is normalized to the incidence angle of 20° by adding the value of $\Delta f(\alpha)$ to the original value.

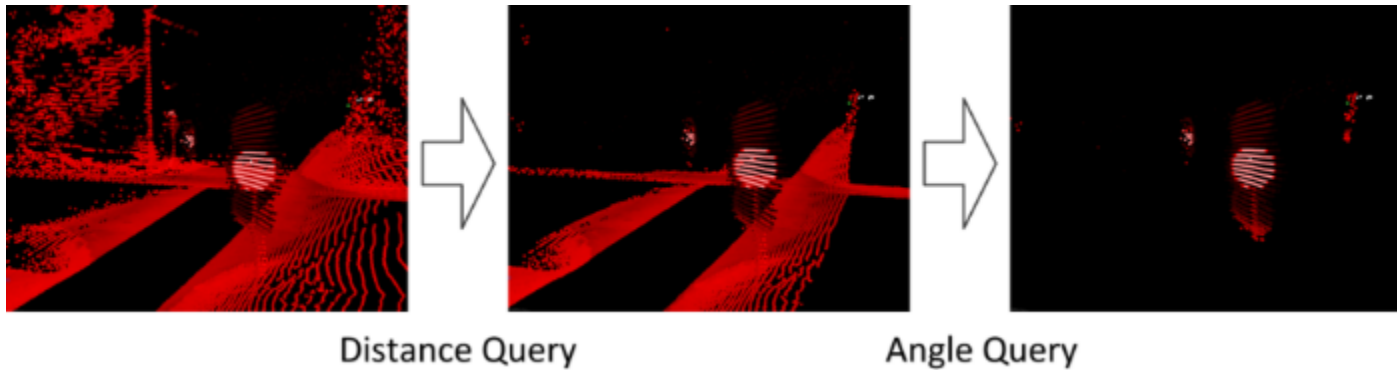
- Initial sign region extraction

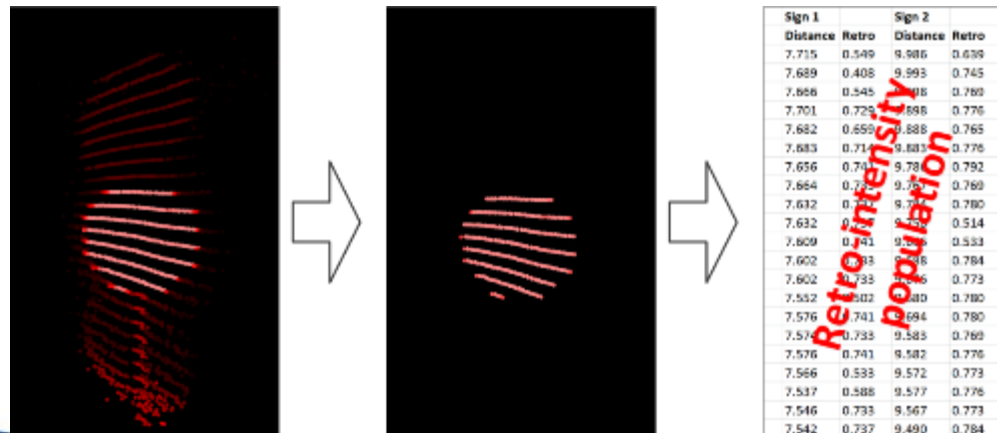
- Boundary effect removal
